Assessment Report for  
Colorado, SPS 2

Visit date: March 17, 2004

A visit was made to the Colorado SPS-2 site on March 17, 2004 for the purpose of conducting an assessment of the WIM system located on Interstate 76, 0.44 miles east of the East 136<sup>th</sup> Avenue overpass, at milepost 20.181.

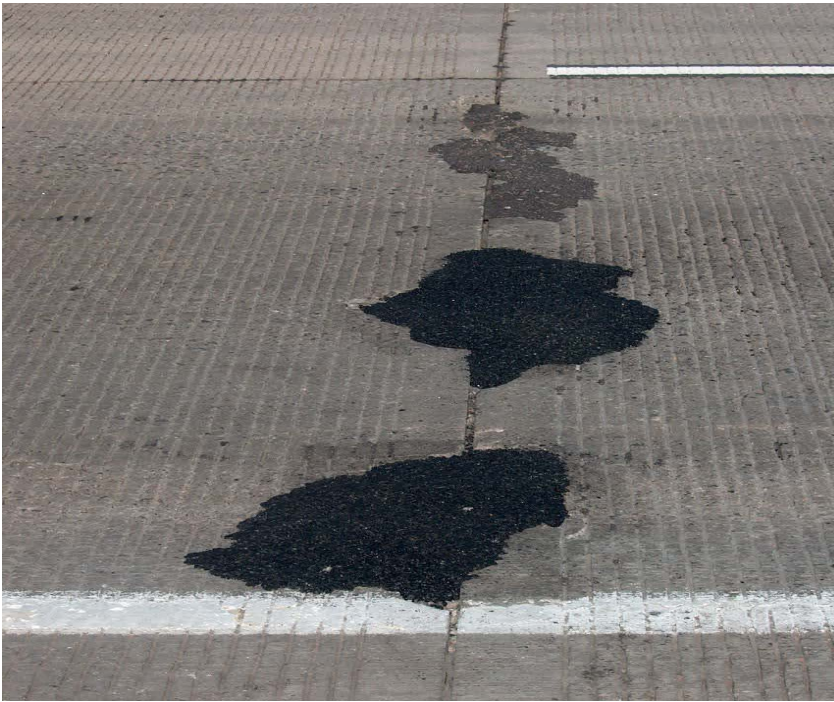
**Figure 13-1 Asphalt Patching 24 feet prior to site**

The pavement condition is such that it may contribute to an inability to calibrate the system to obtain research quality data. At all the locations the WIM Index value of 0.789 m/km is exceeded. Among the distresses observed that might influence the truck motion are asphalt patches at the pavement joints located approximately 24 feet and 84 feet prior to the leading edge of the loop sensor. These are illustrated in Figure 13-1 and Figure 13-2.

The pavement appears to be in good condition except for the patches at 24 feet and 84 feet prior to the WIM scale sensors as shown in Figure 13-1 and Figure 13-2 respectively. Figure 13-3 and Figure 13-4 show the pavement condition at the site in the downstream and upstream direction respectively.

Should pavement replacement not be a viable option, grinding or replacement of the patches should be performed, due to their possible effects on truck dynamics in the WIM scale area.

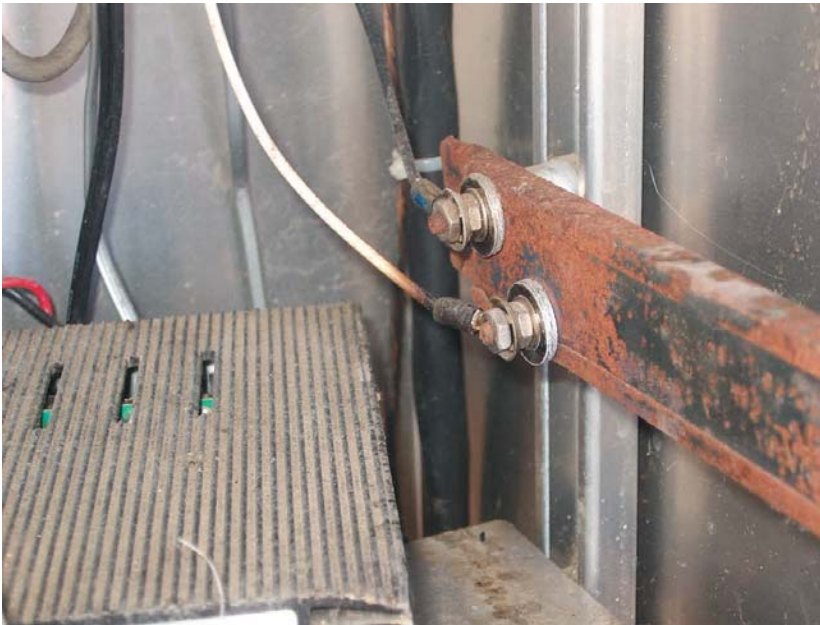
**Figure 15-1 Damage inside the cabinet of 080200**

Due to the presence of electrical short damage on the ground bus bar as illustrated in Figure 15-1, a thorough check of all power service components needs to be performed at the time of system repair or replacement.

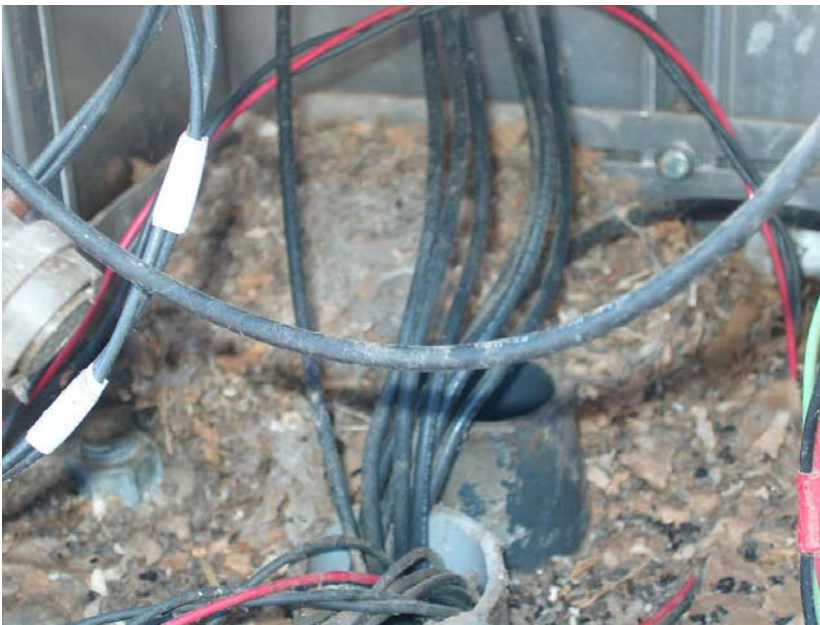
**Figure 15-2 Damage inside the cabinet due to rodent infestation at 080200**

The cabinet is severely infested with rodents as illustrated in Figure 15-2 and needs to be completely cleaned.

A visual inspection of all on-site equipment such as the cabinet, cabinet foundation, in-road sensors, conduit, grounding, and power and telephone system components was performed. Rodents have infested the cabinet. The cabinet door has been damaged and environmental effects and burrowing prairie dogs are excavating the ground around the cabinet foundation.

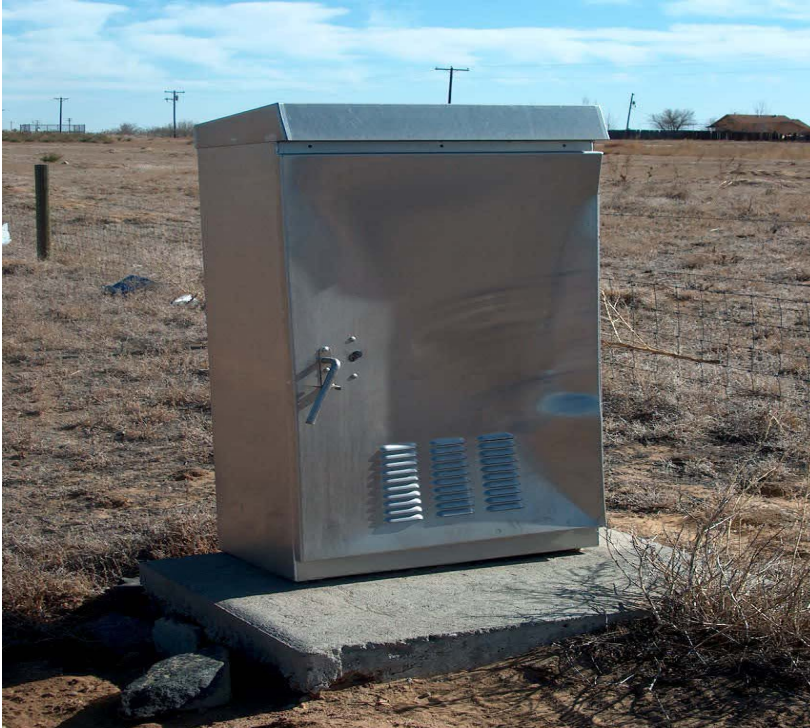
**Figure 15-3 Damage to the cabinet door at 080200**

The cabinet door has been significantly damaged as illustrated in Figure 15-3, and needs to be replaced.
